SUCCESS STORY – ALIMADURAI TANK

Pre - project conditions

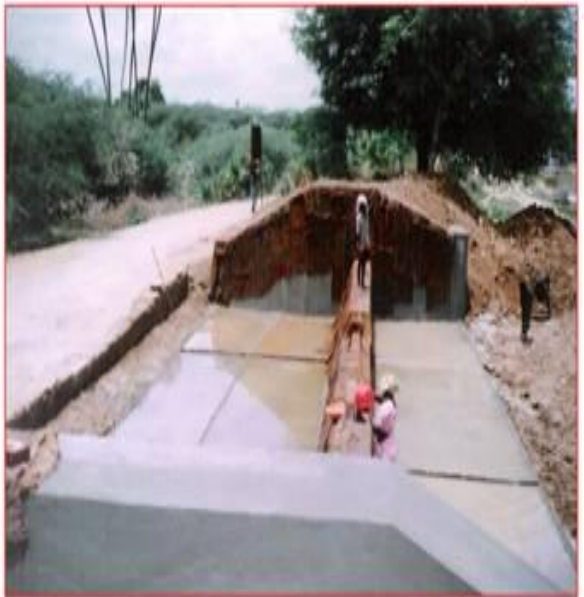
After completion

Thiru.Viswanathan President, Water Users Association of this tank says “The surplus weir has been reconstructed completely with cement concrete. During the recent rains, water stored in the tank about fifty percent of its capacity. This water will be effectively used for first crop cultivation. By the reconstruction of all these structures water wastage has been arrested completely which leads to save more water in the tank. The WUA officials are planning to cultivate second crop (Mostly cotton , chilly , etc.,) with the balance water available in the tank”
