# WATER RESOURCES DEPARTMENT

### UPPER VELLAR SUB BASIN- PERIYA ANICUT PERIYA ANICUT WAS CONSTRUCTED ACROSS PERIYAR RIVER, A TRIBUTORY OF VASISTA RIVER NEAR VALAPPADY IN SALEM DISTRICT.

### PAMBAR SUB-BASIN REHABILITATION OF NEMMENI TANK IN PERIAKOTTAKUDI VILLAGE OF KARAUKUDI TALUK IN SIVAGANGAI DISTRICT

### KOTTAKKARAIYAR SUB BASIN - PULIYUR TANK

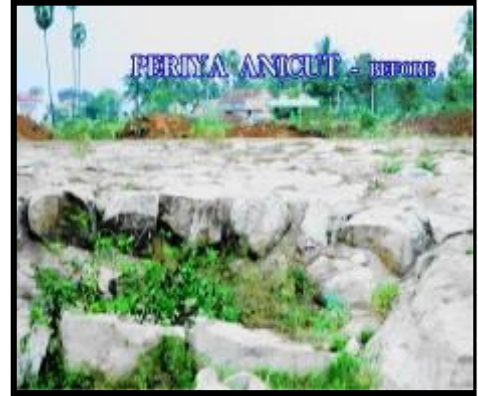
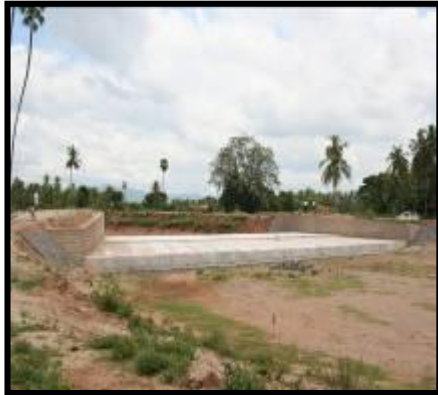
The existing Anicut was constructed in R.R. Masonry long back with an open off take and was in dilapidated condition. The anicut was completely filled up with silt / sand upto the crest level of the anicut.

- 1) Storage capacity restored (Water stored during the rains in July and August of 2008)
- a) Improvement in water level in surrounding wells (as per Ground Water Division Records):-

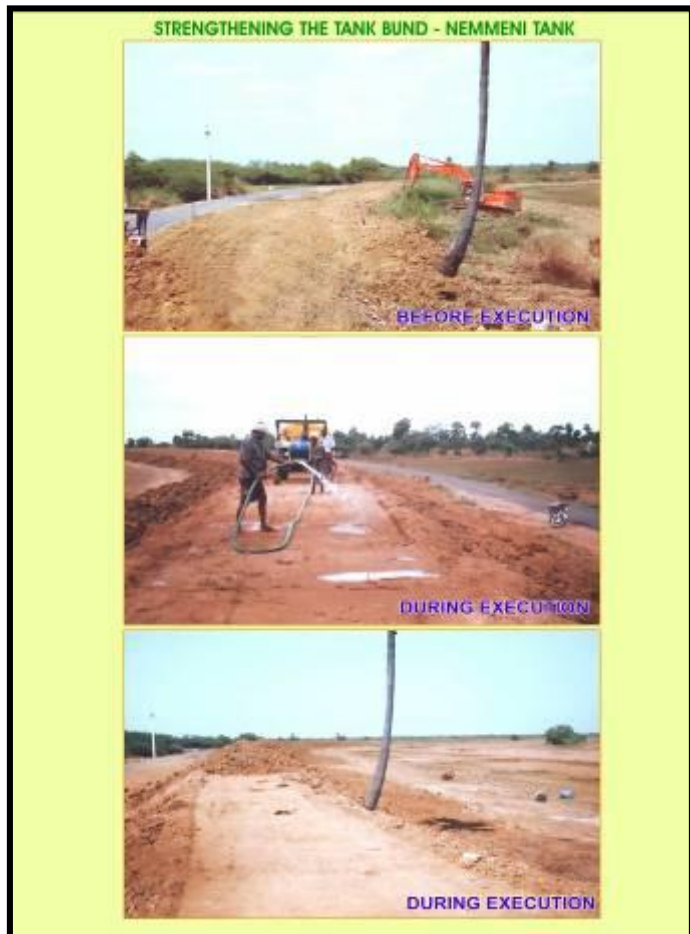
The existing tank bund was weakened, bed silted up and the storage capacity considerably reduced. The existing weir was in dilapidated condition. Existing sluice no.I was damaged and requires reconstruction and repair works to sluice no.II.

- By desilting the tank bed & strengthening the bund the original capacity of tank is restored and the ayacut is being fully stabilised by bridging the gap. Also recurring damages by flood to the bund is avoided.
- By reshaping supply channels, the original designed discharge is restored
- By reconstruction of weir the storage of tank is restored to it's FTL with out any wastage.
- By reconstruction & repair works to sluices effective supply of water to the fields is achieved.

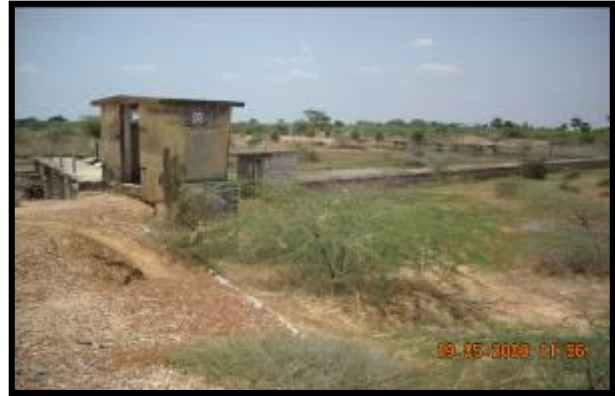
Before Execution

The existing anicut was constructed in R.R masonry during 1990. Anicut is completely silted up and with weakened flood banks, dilapidated apron. Inadequate carrying capacity of silted up & disturbed supply channels and regulatory arrangements.

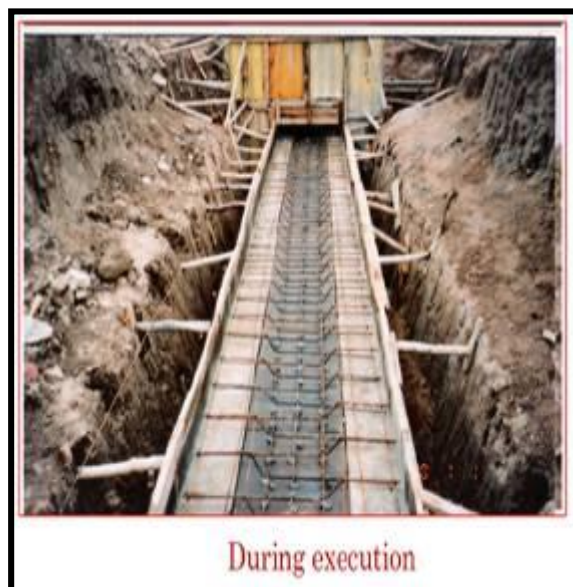
During execution

The Tank bund for its entire length was below standards . Out of the four sluices, two sluices (3&4) were completely in dilapidated condition. There was heavy leakage in all the sluices. The surplus weir was also in collapsed condition . The Head sluice also requires rehabilitation .
